Real Problems in Utility High Voltage Network due to Grid Connected Photovoltaic Power Generation. The experience of Endesa.

Javier de la Cruz¹ & Pedro Gómez²

¹ Endesa Distribución Eléctrica S.L.U.
Escudo del Carmen 31, 18009-Granada, España
franciscojavier.delacruz@endesa.es

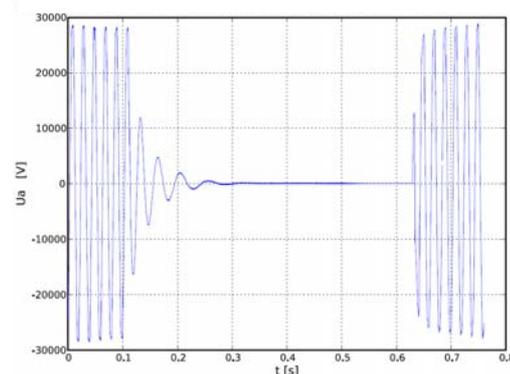
Figure 1. Waveform of the signal in the fault and reclosing in Type I plant

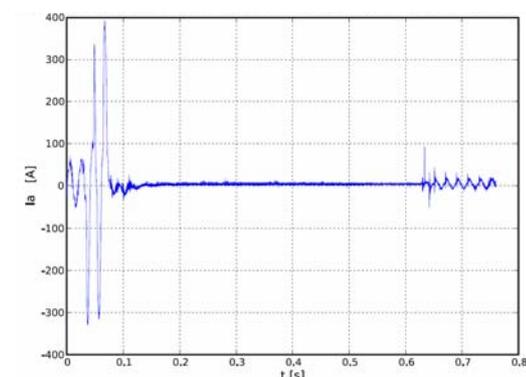
Figure 2. Current level (similar in the 3 phases) in the fault and reclosing in Type I plant

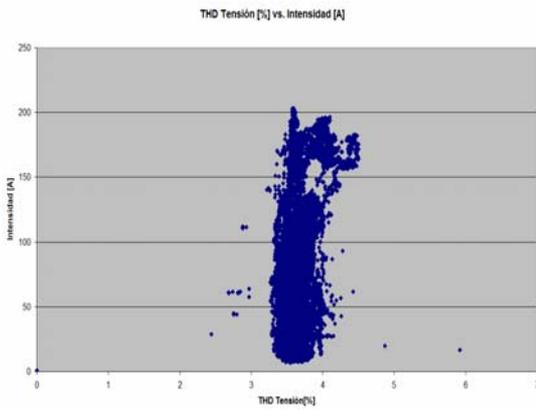
Figure 3. THD vs. current in Type I plant. The value is around 4%, very high compares to the normal Sub value (1.5%) but under the recommended 5% [5].

This is an important indicator of the quality and good design of the inverter: High cost inverters offers low THD values

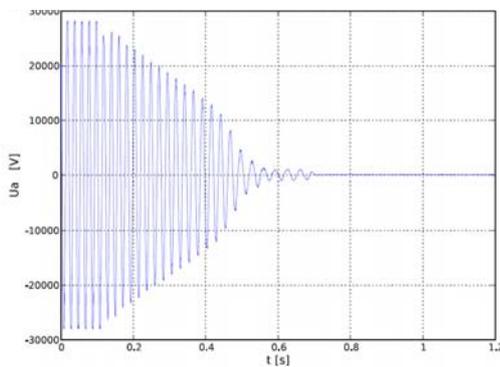
Figure 4. Type I plant. Example of a normal switch off. Abnormal 40Hz_z generation state after islanding of the plant

We couldn't see any abnormal behaviour in this graphic with the exception of the strange pure 40Hz_z generation (less than the 50 Hz_z standard in Europe) with a constant slope ratio between voltage and time, just after the islanding of the PV installation and subsequent switch off of the generation power when the real value is under 20%-25% of nominal power. This situation holds up for around 0.5 sec.

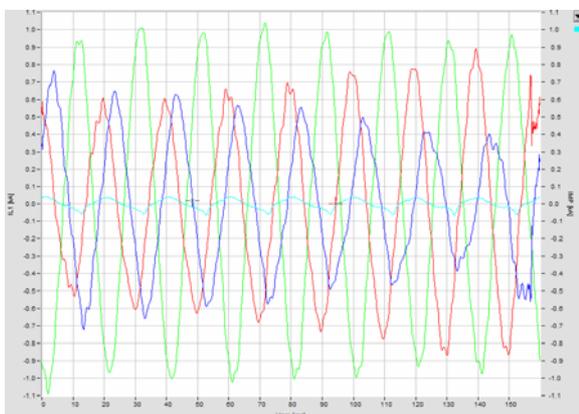
In a Type II plant with the same problem, we made a programmed malfunction of the PANTAM Sub. transformer's voltage regulator, lowering it from 17 Kv. to 15 Kv. No problems were observed, but when we increased the value, by turning up the voltage to its normal level (17 Kv.) the inverter got into in a stable state point with significant imbalances between phases and currents modulated at low and high frequencies (Fig. 5,6,7 & 8).

Figure 5. Type II plant: Waveforms of current and voltage.

We can see the irregular generation described in the resonant state. Obviously these problems could flow to our power grid making our quality parameters get worse

inverter's manufacturer, or the other PV plants explained, because the different conditions. After a new programming of the inverter, the problem disappeared. The manufacturer made the changes to equipment with same problem in a plant not described in the paper with the same good result

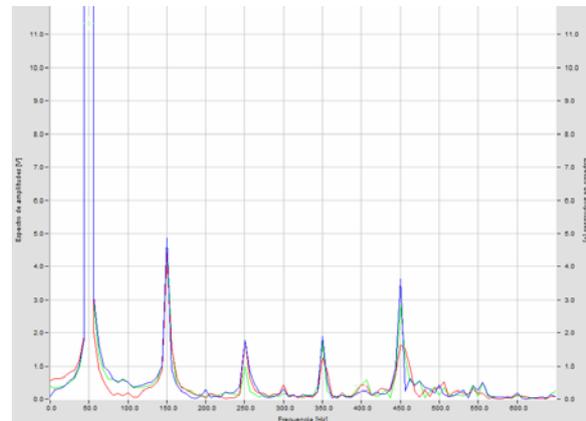
The manufacturer's engineering team thought that the problem was due to the 8th and 10th harmonic produced by the inverter (Fig.6). But after a change in the programming of the internal logic to solve that, the problem was still occurring.

Figure 6. Voltage Phase & Neutral Harmonics in Type II plant

It's relevant the unique out of bounds value at 50 Hz. The other harmonic multiples, including the 8th and the 10th commented before by the manufacturer as origin of the problem, have low values in this case.

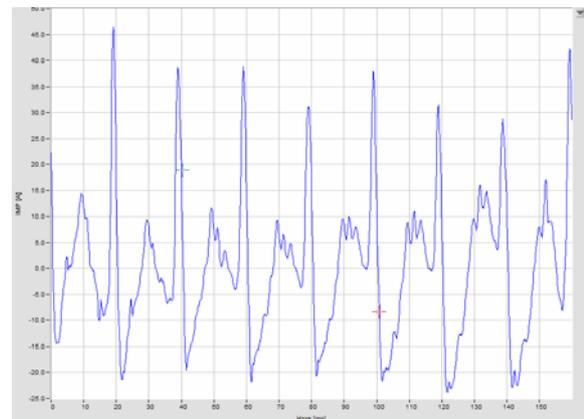
Figure 7. Type II plant: Neutral Intensity waveform with a peak over 45 A in the abnormal stable state.

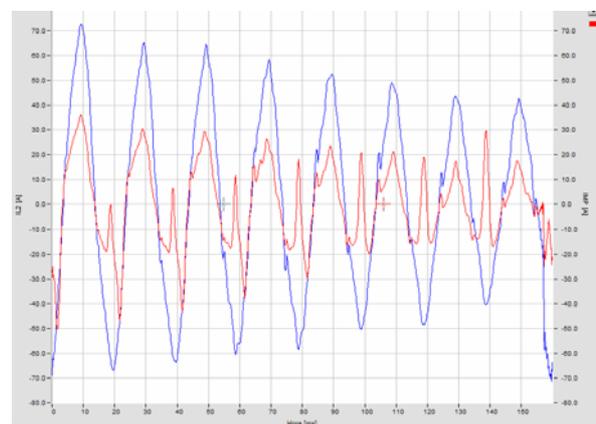
Figure 8. Phase & Neutral current waveform in the Type II plant during resonant state.

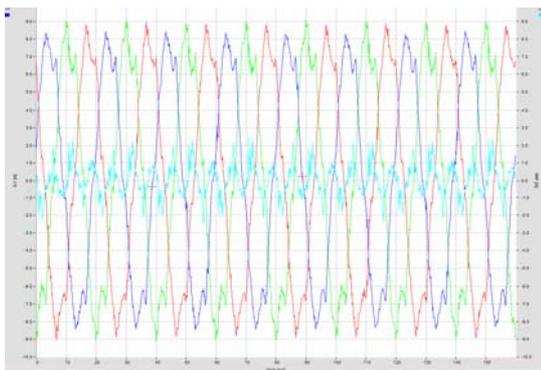
This “exotic” configuration of the manufacturer causes a great degradation of the signal at low power levels (less than 22% or 18% of the nominal value) in the initial moments previously described. This state is defined also by a big imbalance of the phase values. One time the real power exceed the low nominal values, generation is well balanced.

Figure 9. Current waveform in the starting process in Type III plant. The degradation of the signal values is evident

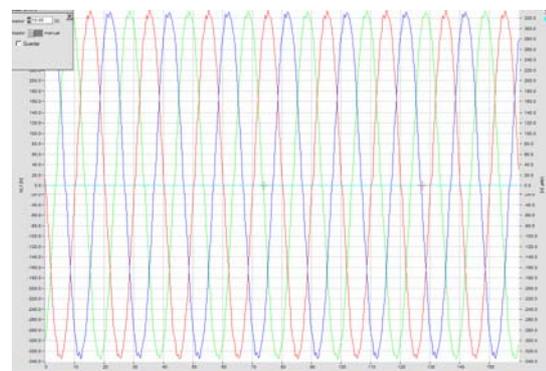
Figure 10. Type IV plant: Initial voltages in a serial panel starting

No abnormal behavior could be detected in this measurement discarding the harmonic effects

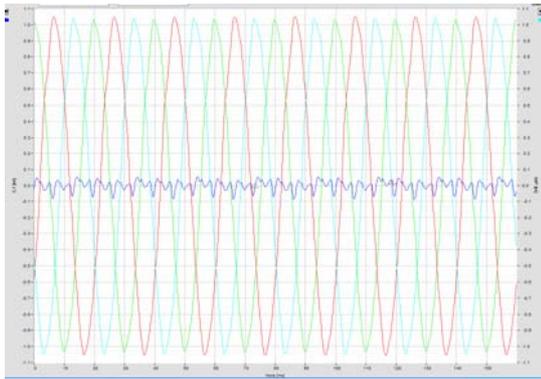
Figure 11. Currents at normal operation in Type IV plant. All values are in normal range.
