# Voltage Measurement Errors as a result of Multiple VT Groundings

**Abstract.** On 12 December 2007 a distance relay tripped erroneously by zone 1 for a ground fault in an adjacent line. RTDS simulations and theoretical calculations proved that the relay had operated according to its design parameters and that the settings of the units involved were adequate. Further analysis of the fault recordings showed that the currents followed a single-phase to earth fault pattern, whereas the voltages did not follow any known pattern for the conventional types of faults.

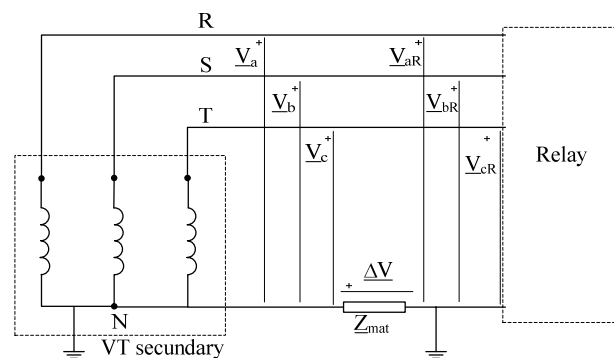
When the VTs are grounded both at the VT location and at the relay location (usually in the relay housing) the situation illustrated in Figure 1 arises.

As it is shown in the paper the situation can go unnoticed since direct sequence voltages measured in the relay housing are measured correctly in spite of the multiple grounding because the  $\Delta V$  component of the voltages does not affect this measurement. In fact, only the zero sequence voltages measured in the relay housing are affected.

Fig. 1. Groundings in VT and relay locations.

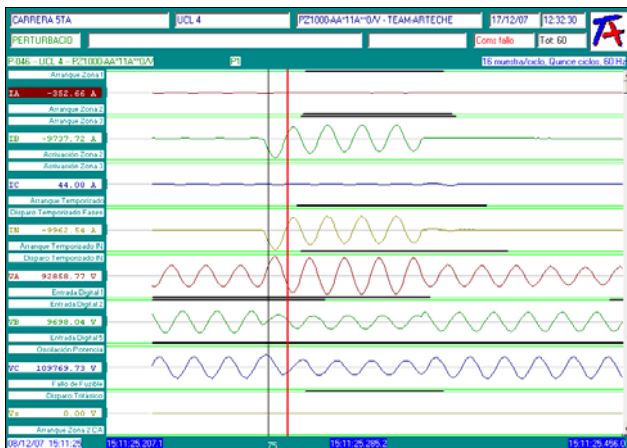
Fig. 2. Fault Data Record.

The actual fault data record is presented in Figure 2 and the corresponding phasors in Figure 3. It can be seen that the currents follow a phase B to ground fault pattern (the phase B and neutral currents acquire much higher values than load current) but the voltages show a very awkward response. The A phase voltage almost doubles the pre-fault value while phase B and C voltages shrink from

normal pre-fault values to fault voltages. In the case of the “C” phase that reduction in the voltage is not associated with a higher current in that phase. This effect can only take place in a weak infeed situation but the current of phase B clearly shows that it is not the case.

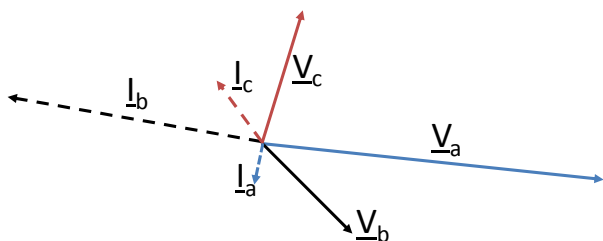
Fig. 3. Fault Phasors.
