Introduction

PV plant features:

- Rated power: 2.85 MW.
- N° of PV modules: 13485
- Technology: polycrystalline
- PV module classes: 18

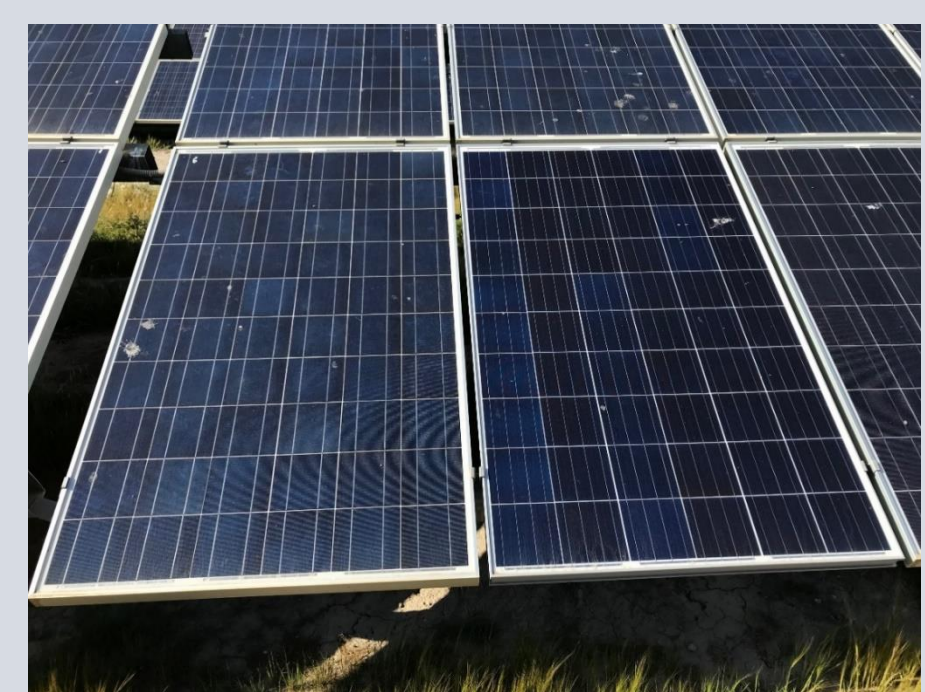
Connection of different PV mod.

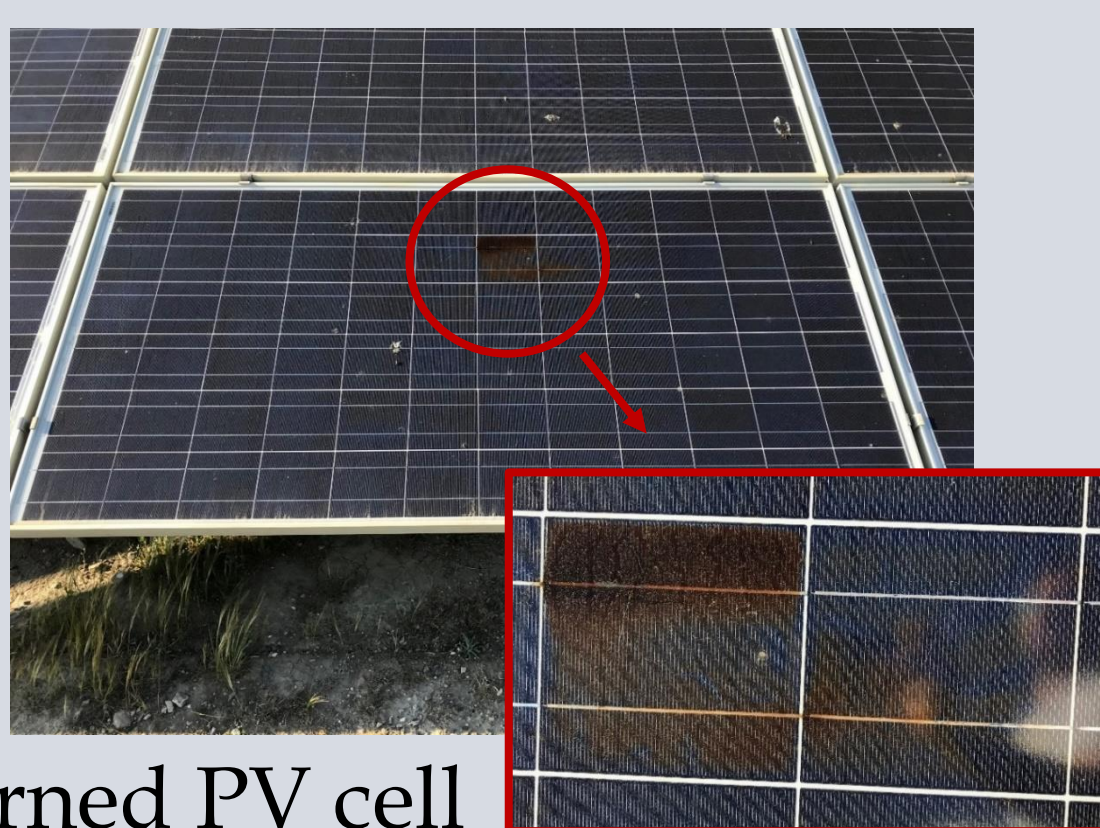
Burned PV cell

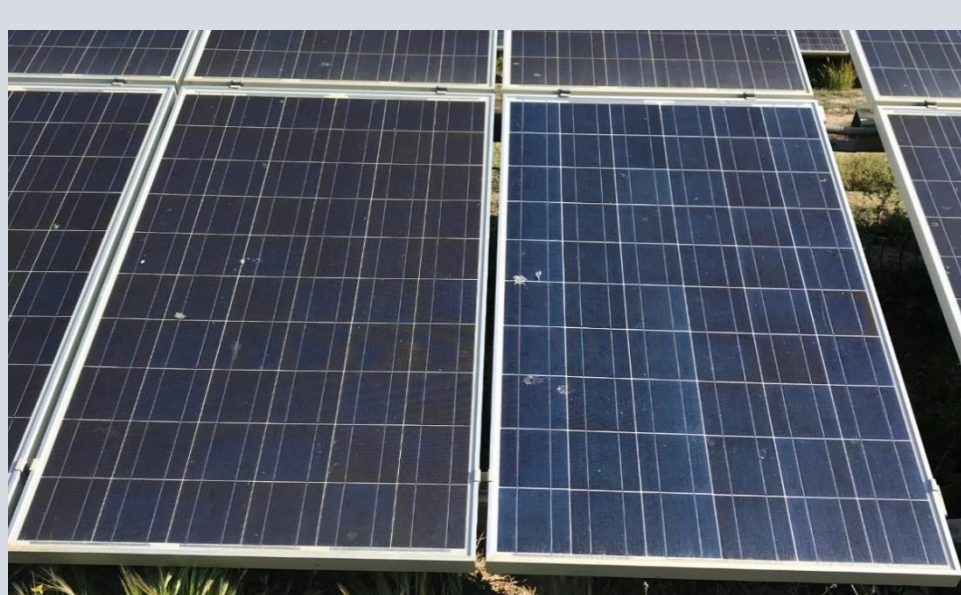
Discoloration

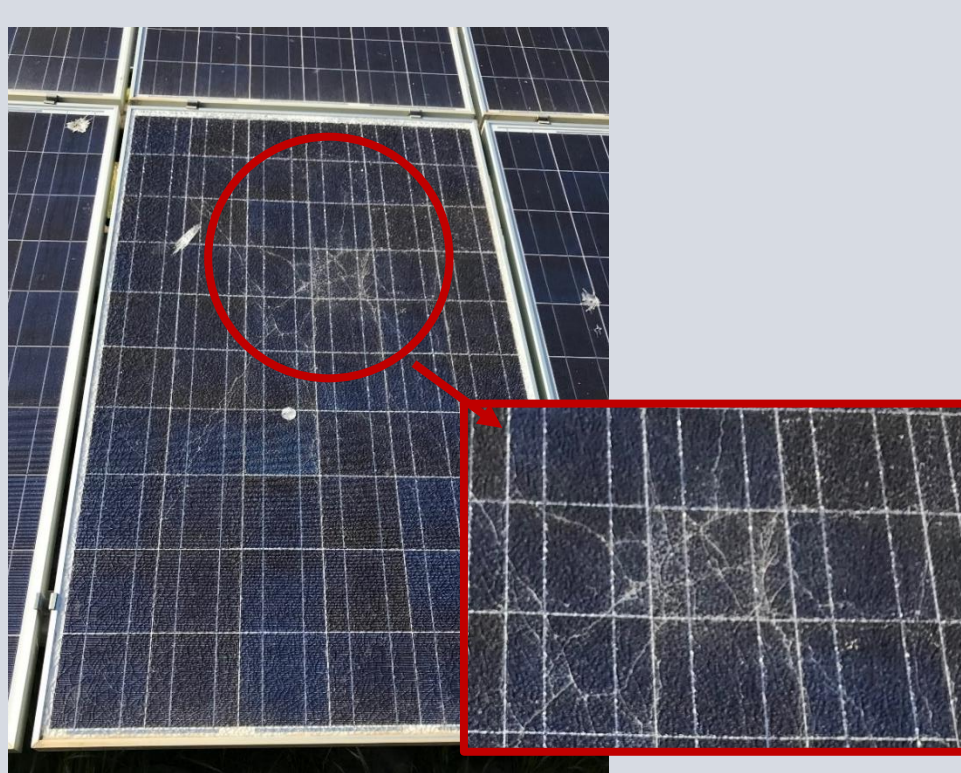
Broken front-glass

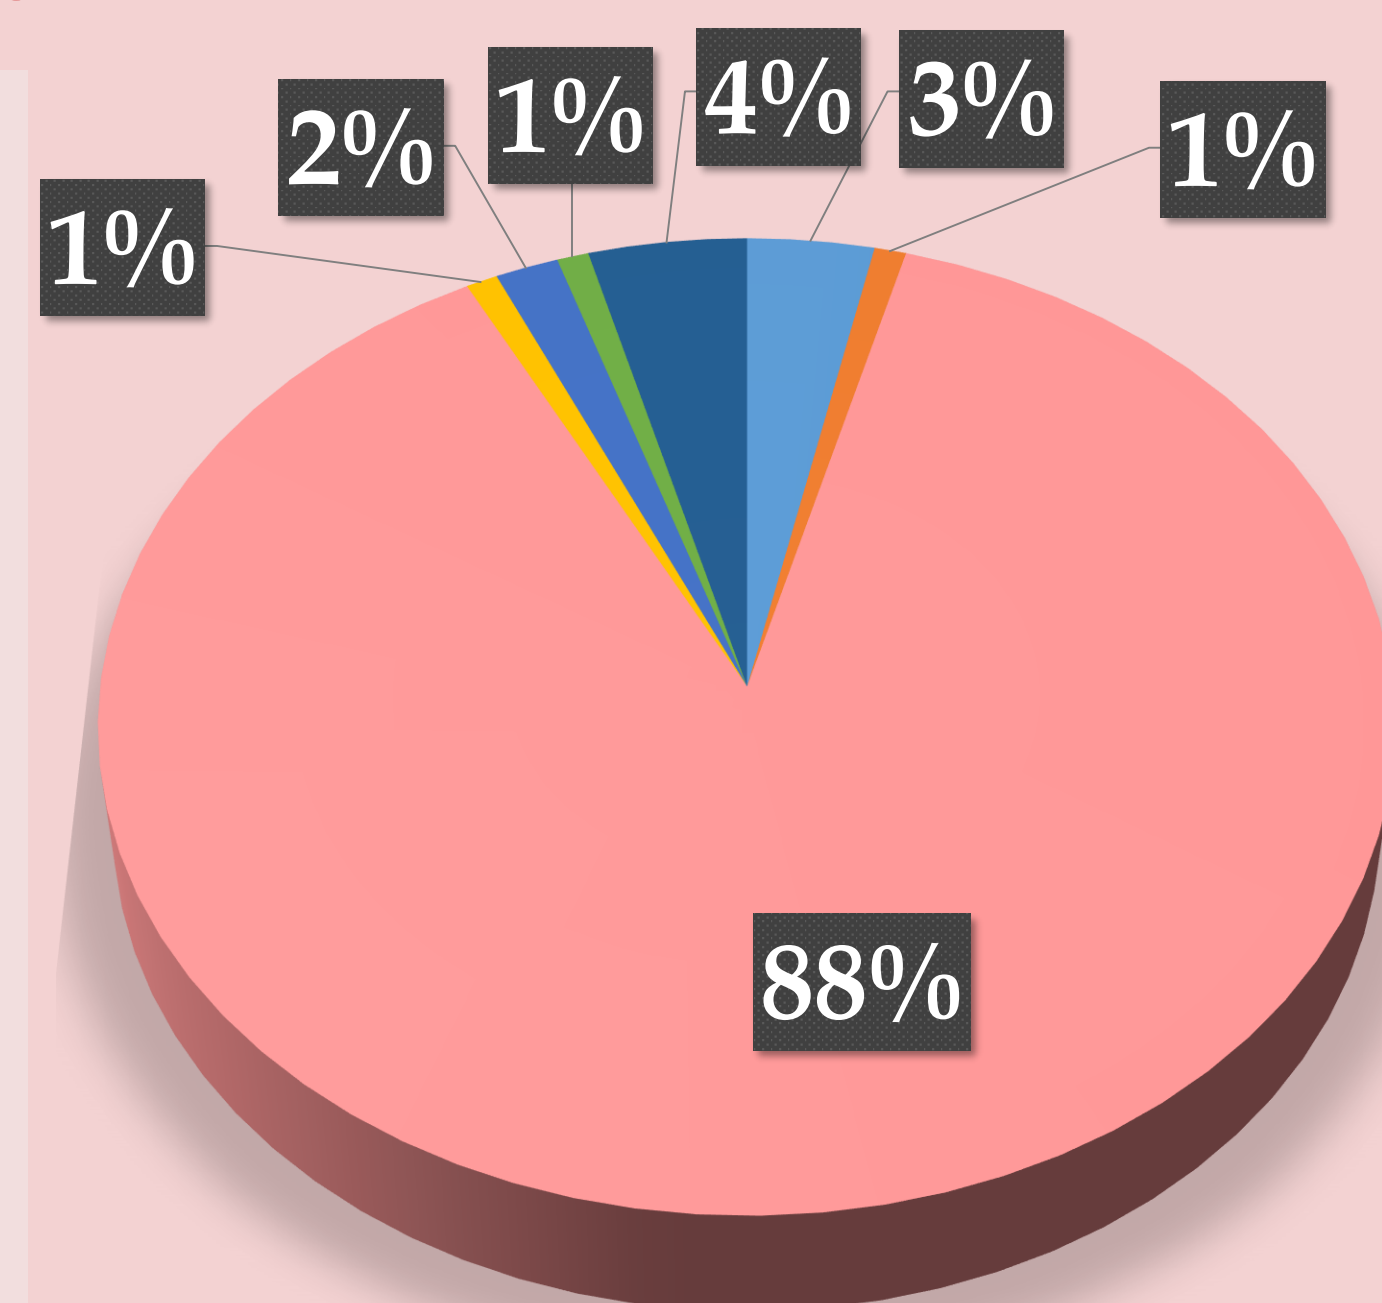
3. Infrared (IR) thermography

- PV String disconnected
- Junction box burned
- Hot spots
- PV module disconnected
- PV module short-circuited
- PV module shaded
- PV module substring disconnected

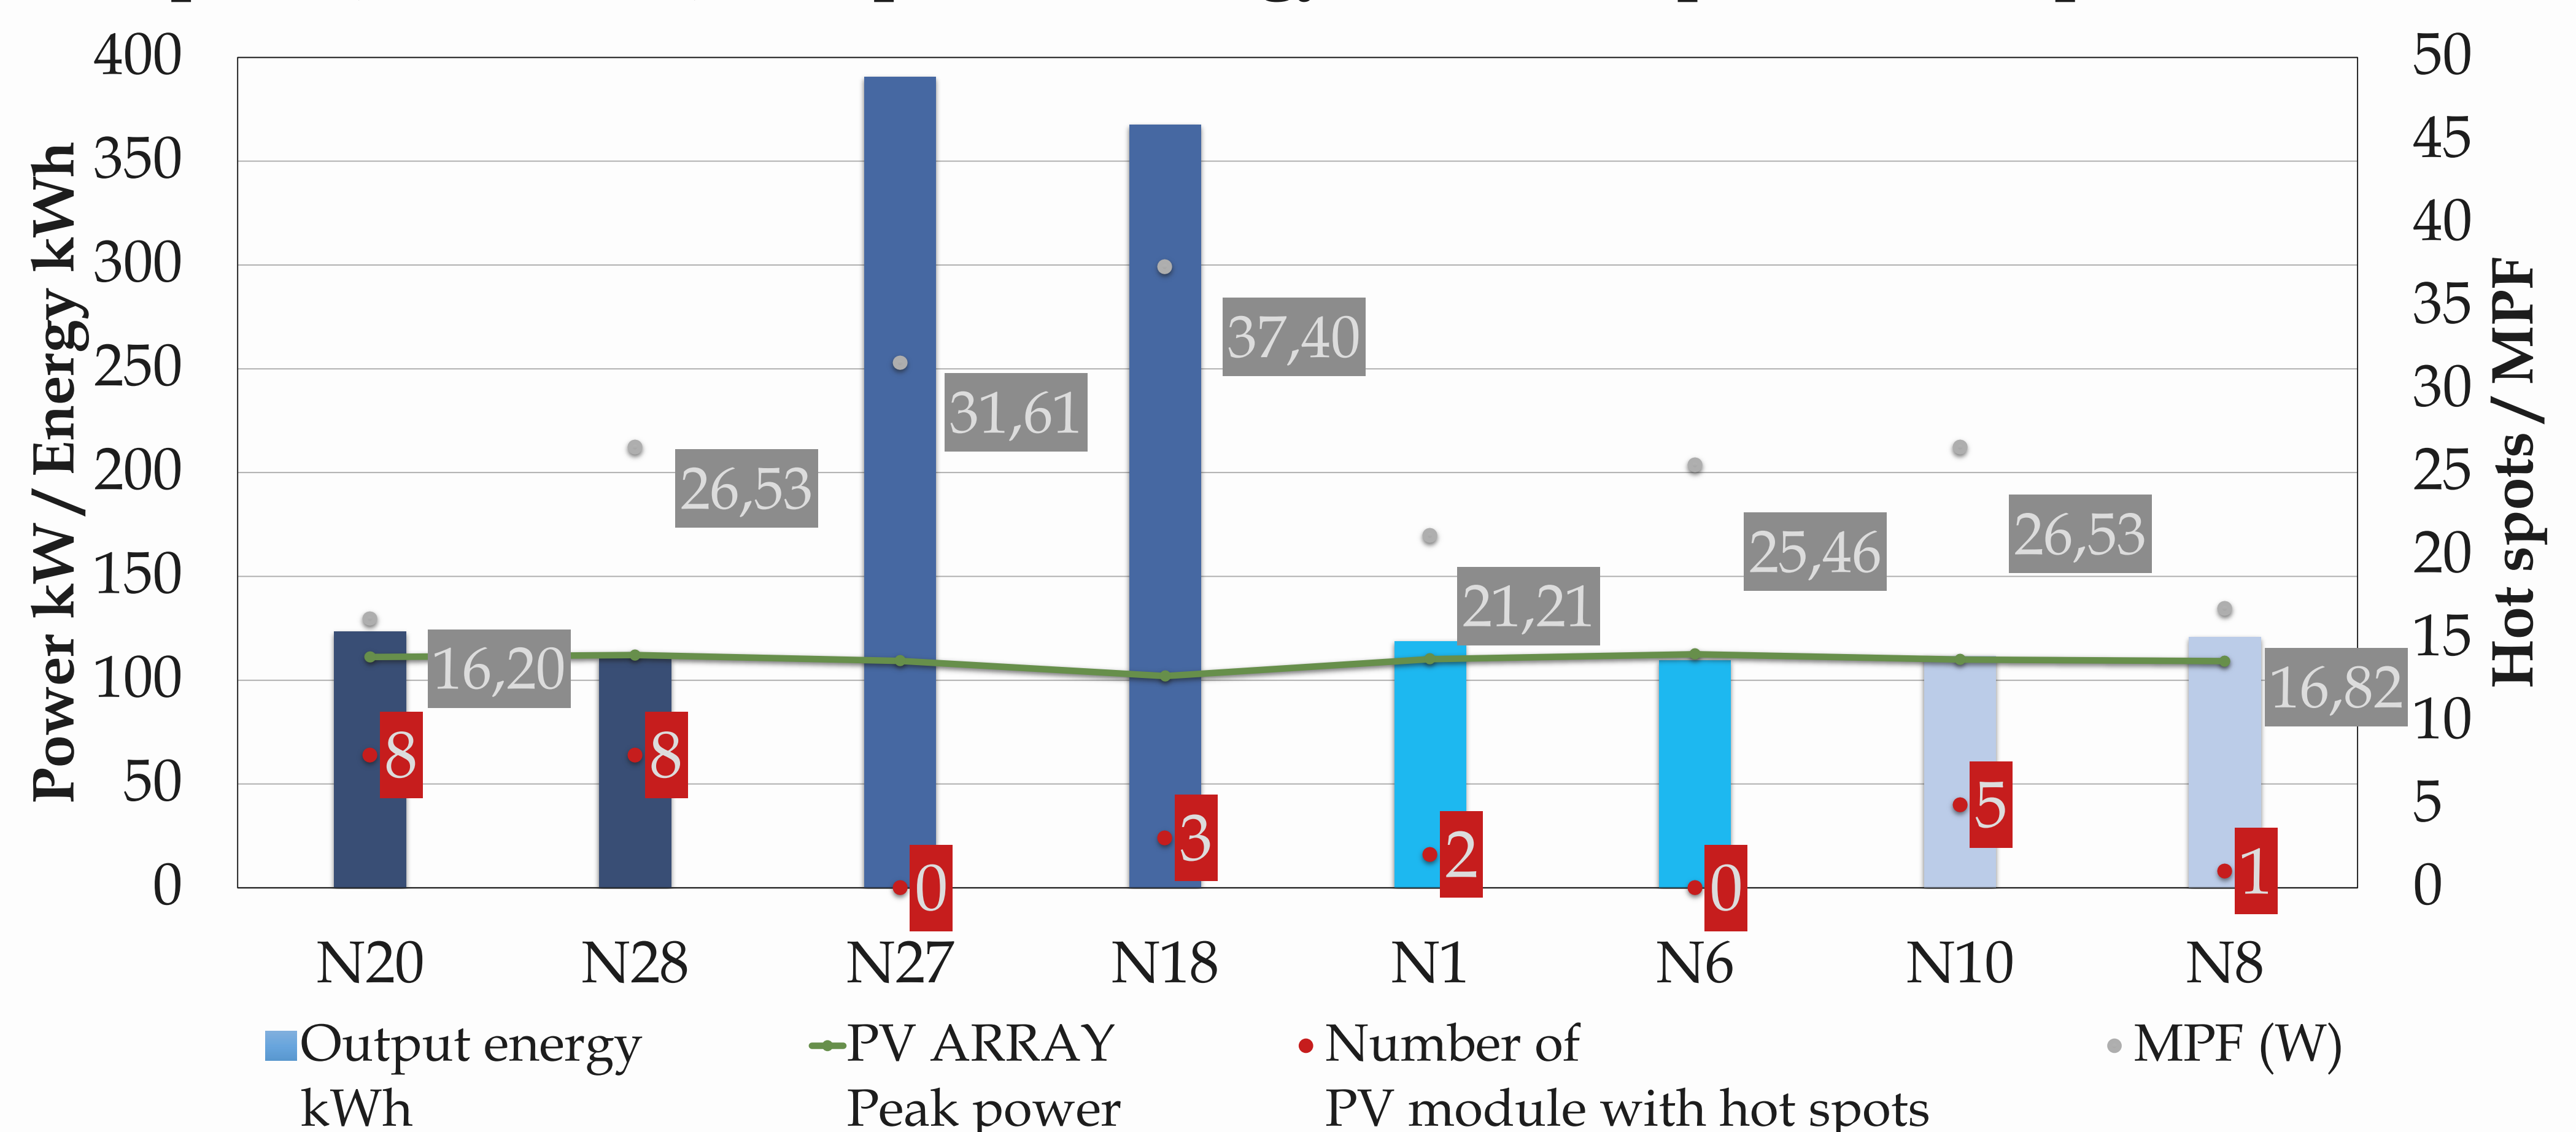
Peak power, mismatch, hot spot and energy relationship in the compared inverters.
