# Vibration and freeze – thaw cycling tests to characterize PEM fuel cells stacks to use in vehicles

18<sup>th</sup> International Conference on Renewable Energies and Power Quality (ICREPQ'20)  
 Granada (Spain), 1<sup>st</sup> to 2<sup>nd</sup> April 2020  
*Renewable Energy and Power Quality Journal (RE&PQJ)*  
 ISSN 2172-038 X, Volume No.18, June 2020

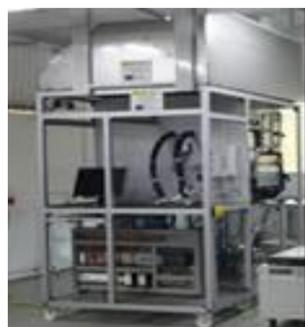
### TEST RING FOR PEMFC STACKS 1 – 10 kW

Capacity of stack testing up to 130 cells.  
 Operation pressure range: up to 2 bar<sub>g</sub>.  
 Operation temperature range: up to 75 °C.  
 Electronic load: 0 – 160 V and 0 – 500  
 Humidification by cartridges: semipermeable membrane  
 Liquid and air thermal management  
 UNE – EN 62282 – 2 . Fuel cell modules.

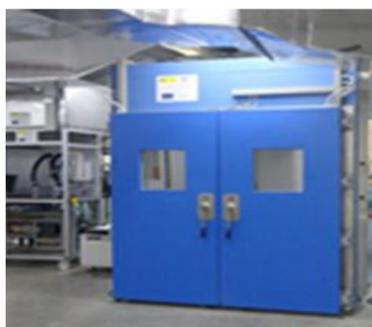
### WALK-IN CLIMATE CHAMBER

Walk-in climate chamber of 16 m<sup>3</sup> useful volume.  
 Operation temperature range: -40 – 75°C.  
 Operation relative humidity range: 10 – 95%.  
 Temperature ramp up / down: 3,8 / 1,4 °C/min.  
 Working dimensions: 2360 x 3240 x 2800 mm.

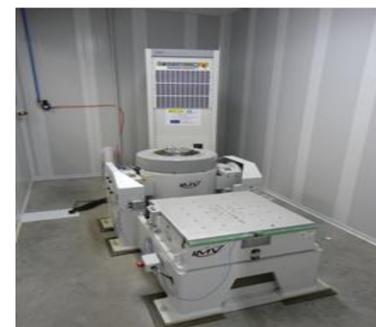
### VIBRATION PLATFORM

Maximum par generated of 8 kN.  
 Programable frequency range: 0 – 2200 Hz.  
 Sine, random and shock operation modes.  
 127g in sine mode and 89g rms in random mode.  
 2,2 m/s in sine mode and 3,5 m/s in shock mode.  
 Sliding table of 630 x 630 mm.  
 Maximum weight on sliding table: 200 kg.
