Introduction

PV plant features:

- Rated power: 2.85 MW.
- N° of PV modules: 13485
- Technology: polycrystalline
- PV module classes: 18

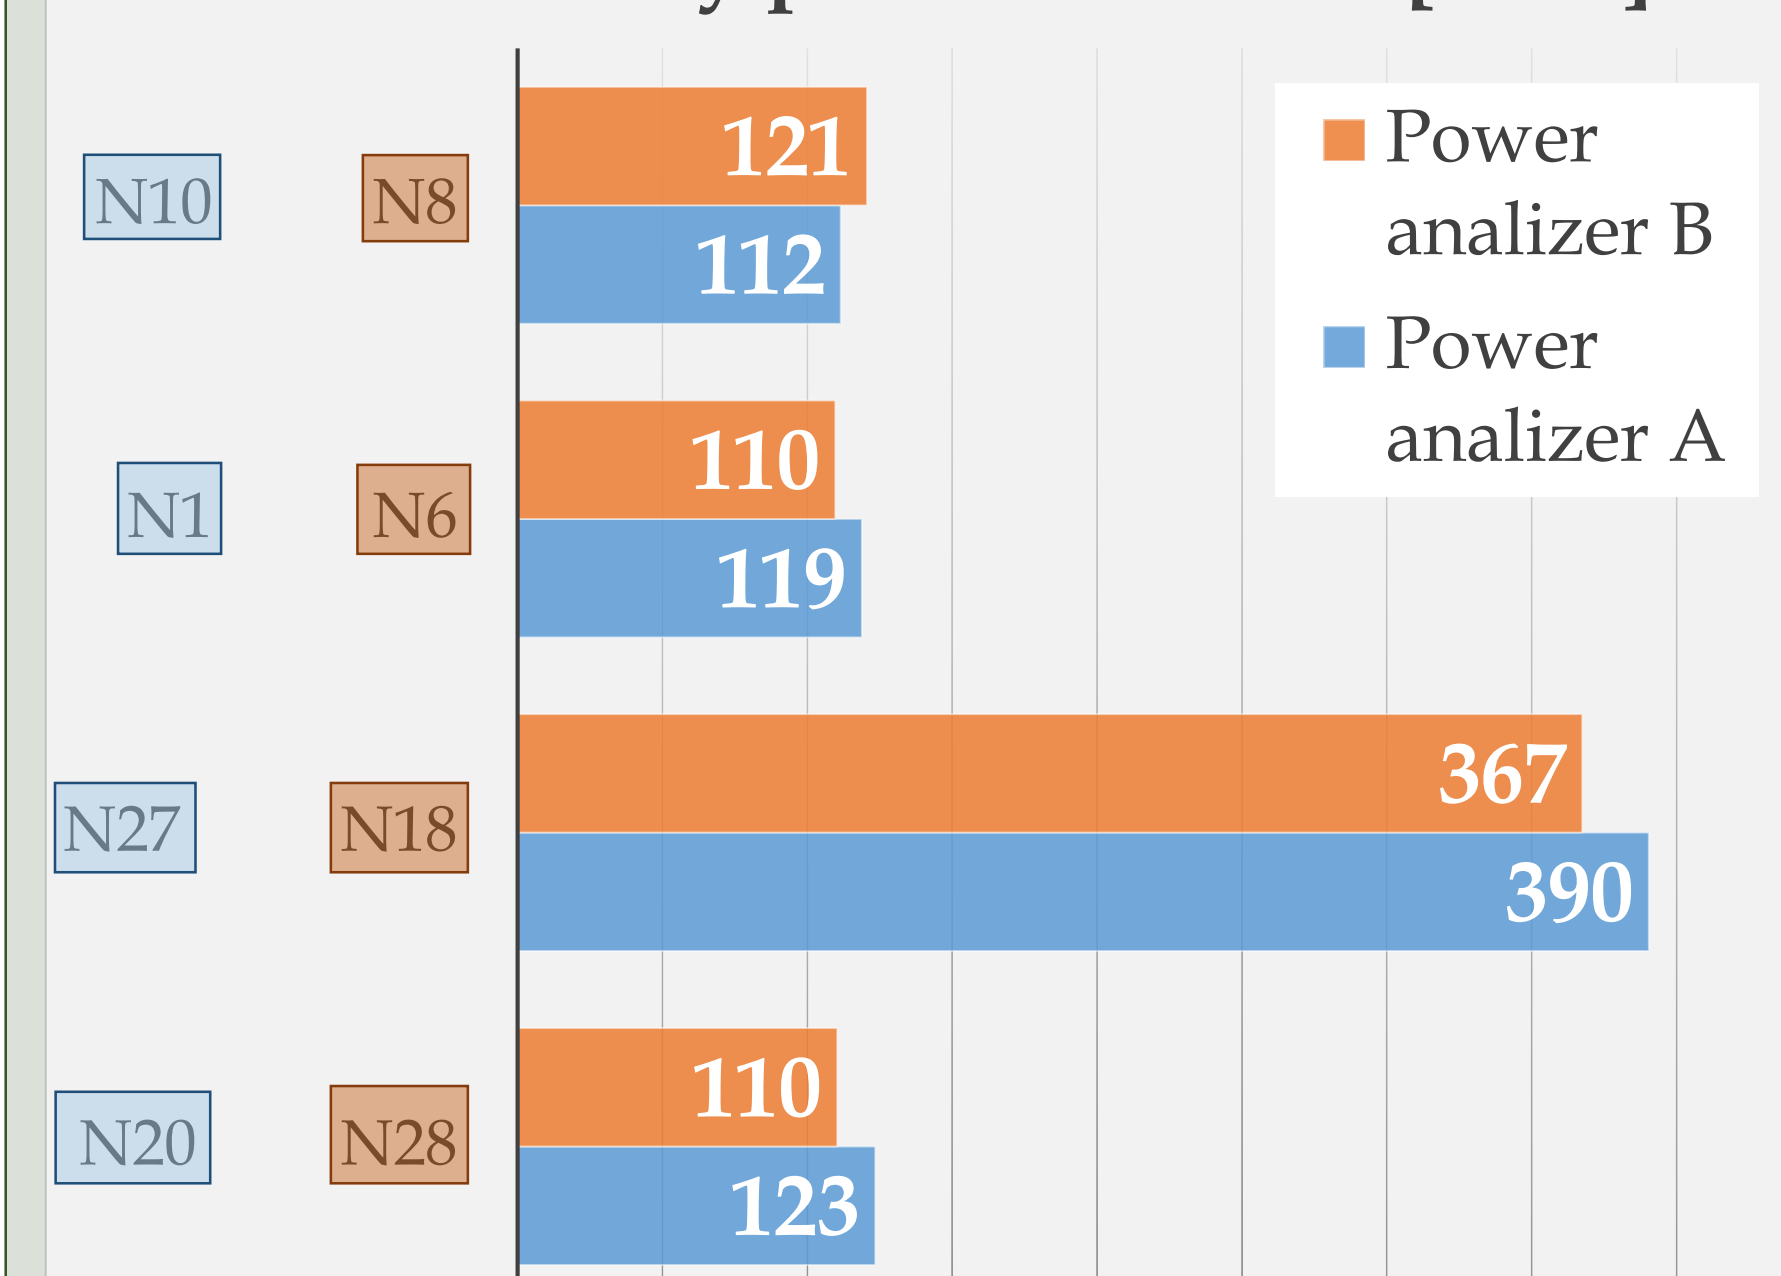
Comparison of output energy measured by power analyzers [kWh]

Peak power, mismatch, hot spot and energy relationship in the compared inverters.
